SITE NAME: Chemetco**CERCLIS ID** ILD 048 843 809**COUNTY:** Madison**DATE:** 04/01/08**TIME:** 1100**PHOTO BY:**

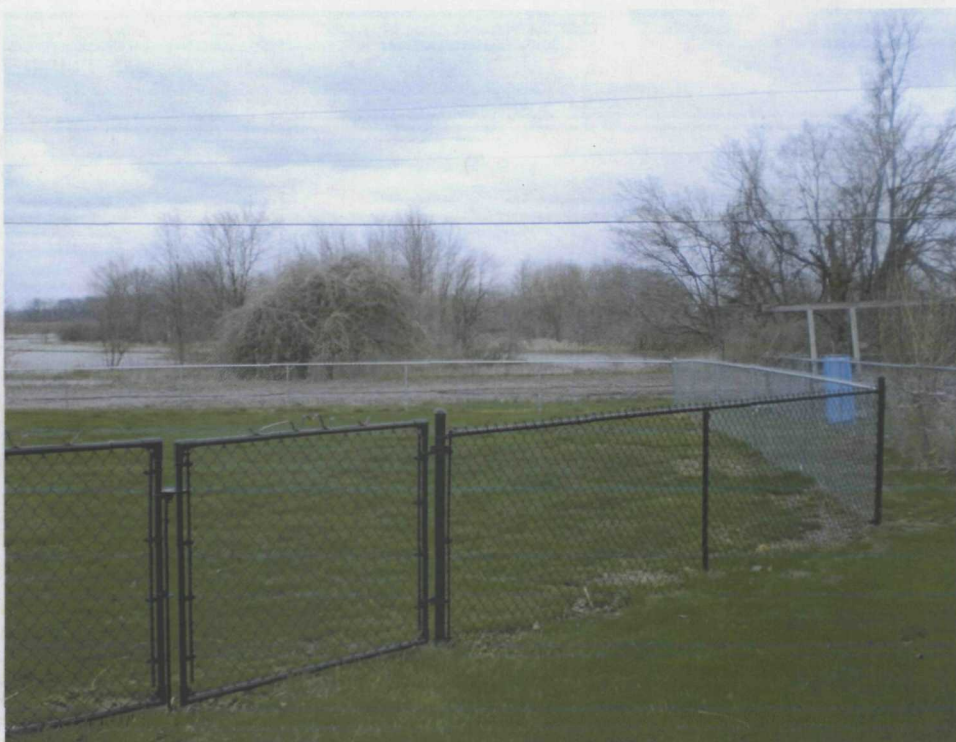
COMMENTS: Photo taken from a residential yard. Photo depicts Long Lake overflowing its banks.

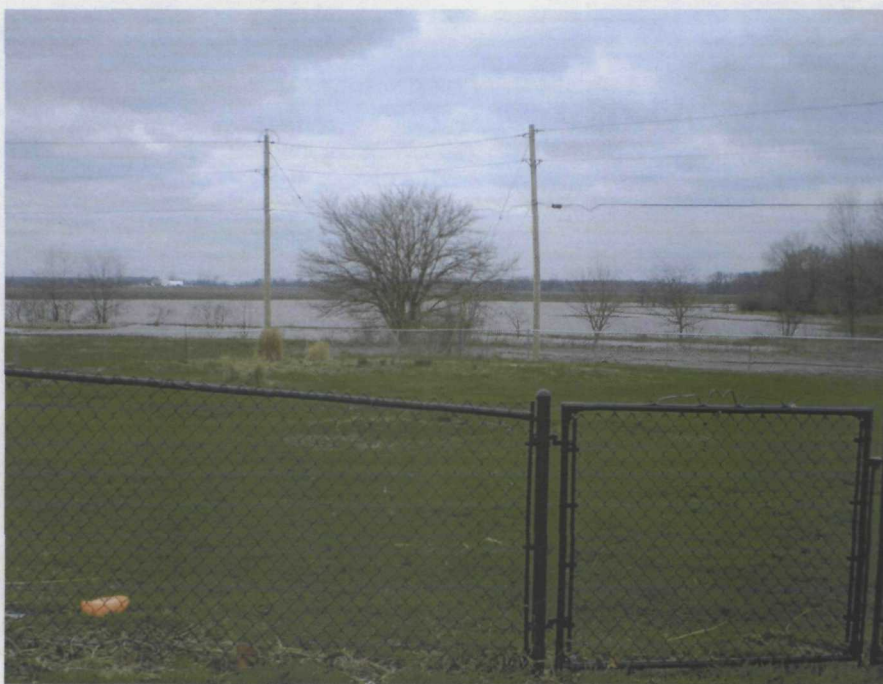
COMMENTS: Photo showing Long Lake outside its banks and in the fields. Photo taken from a residential yard.

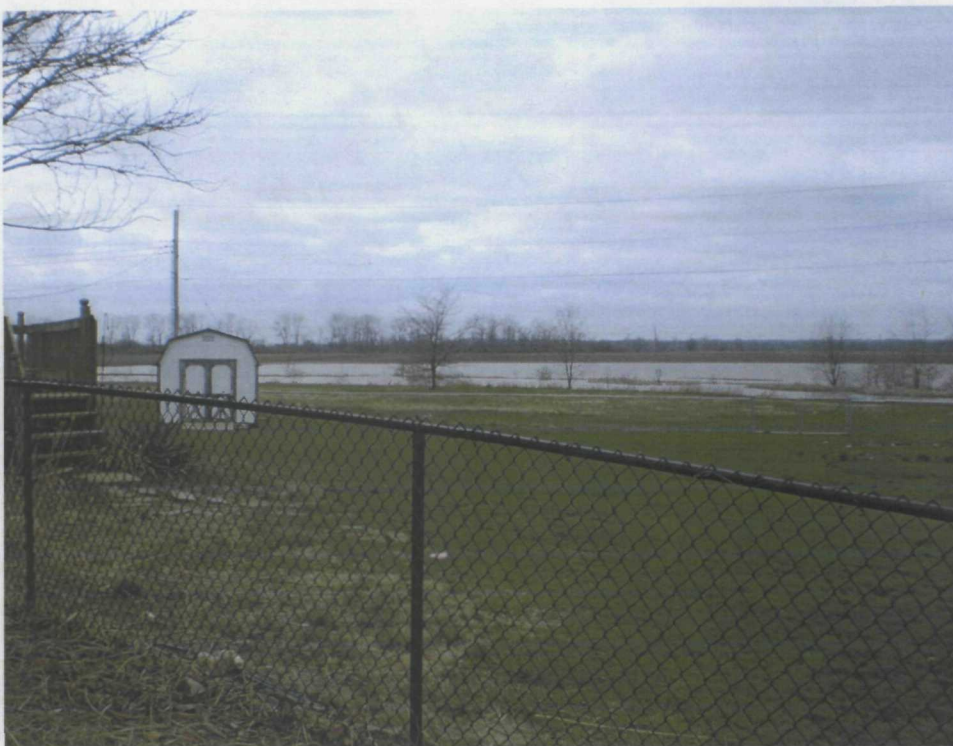
COMMENTS: Photo taken of Long Lake outside its banks.

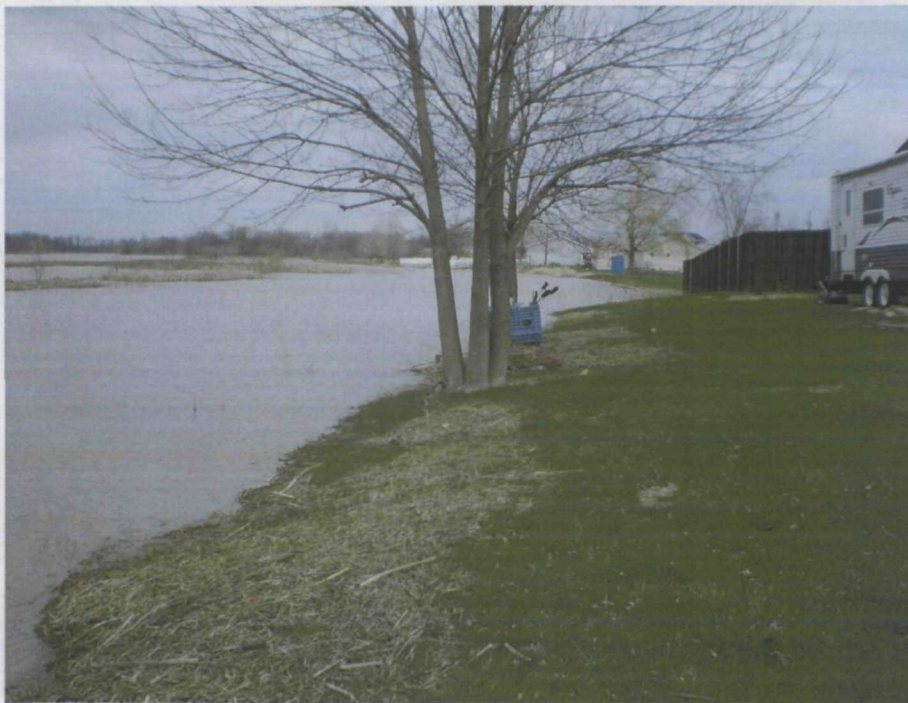
COMMENTS:
Photo taken of Long Lake. Long Lake had flooded the fields to the west. Notice the debris in the residential yards from the influx of water from Long Lake.

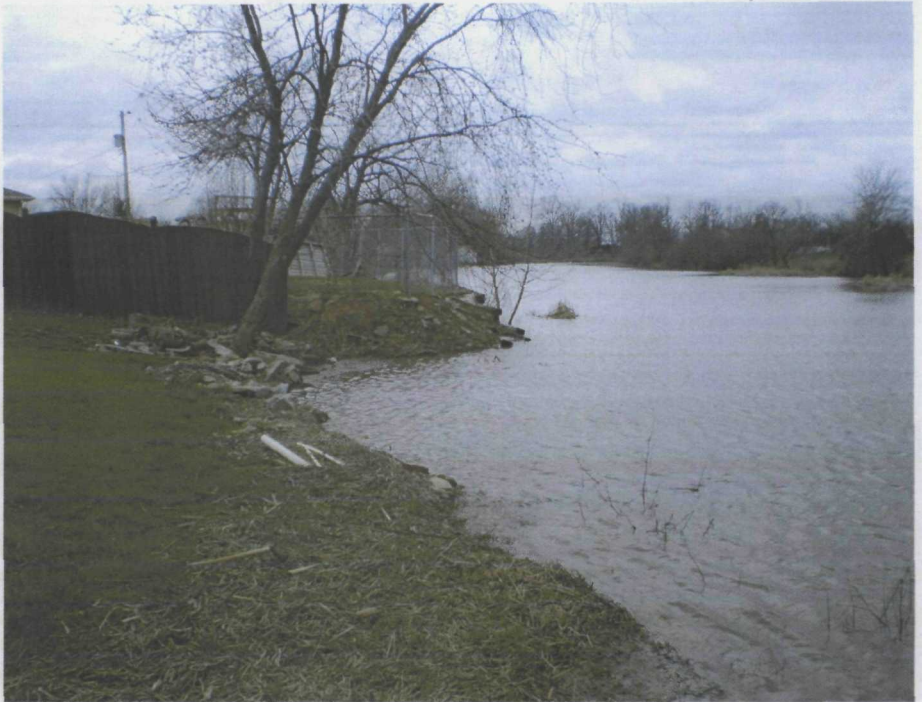
Picture taken of the debris in residential yards from the elevated levels of water in Long Lake.

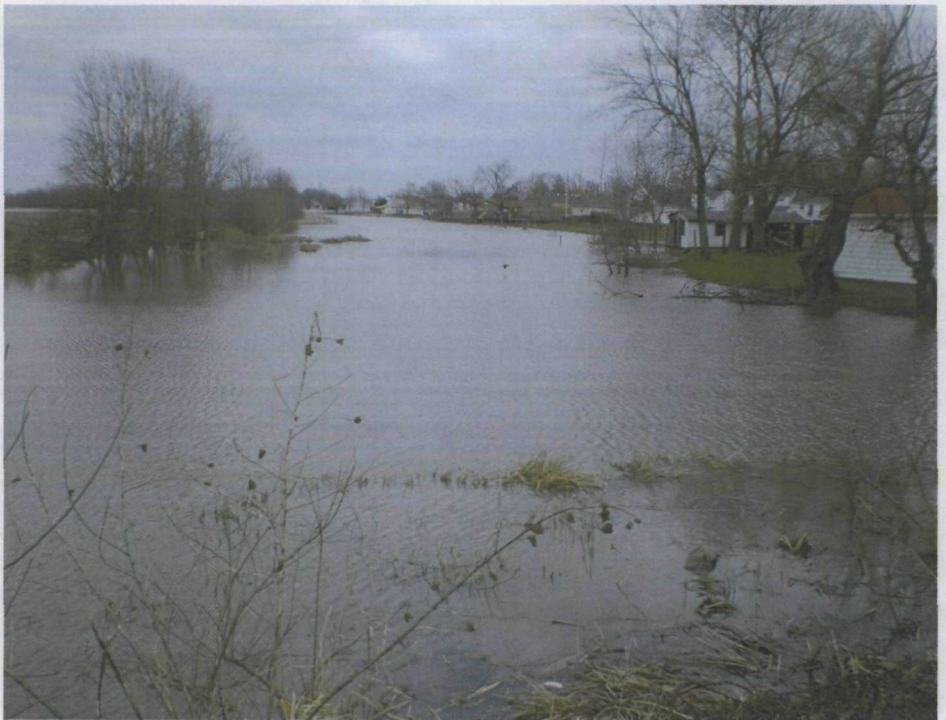
COMMENTS: Photo taken of Long Lake. Long Lake had exceeded its banks and had flooded residential yards.

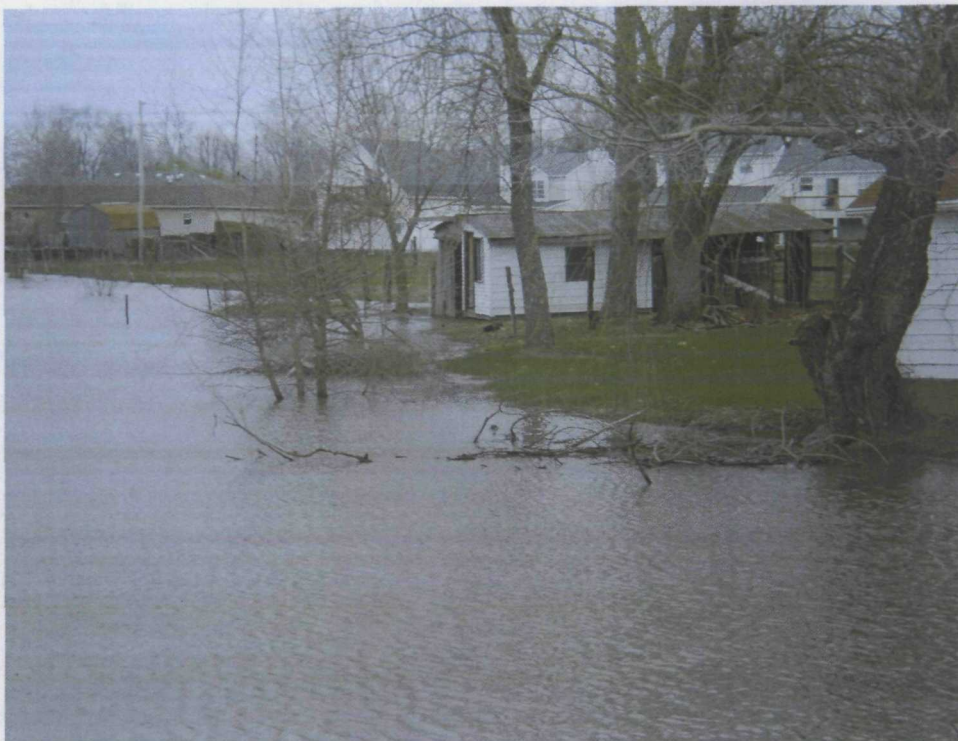
COMMENTS: Photo taken of Long Lake. The Lake had flooded peoples yards and sheds as depicted in this photo.

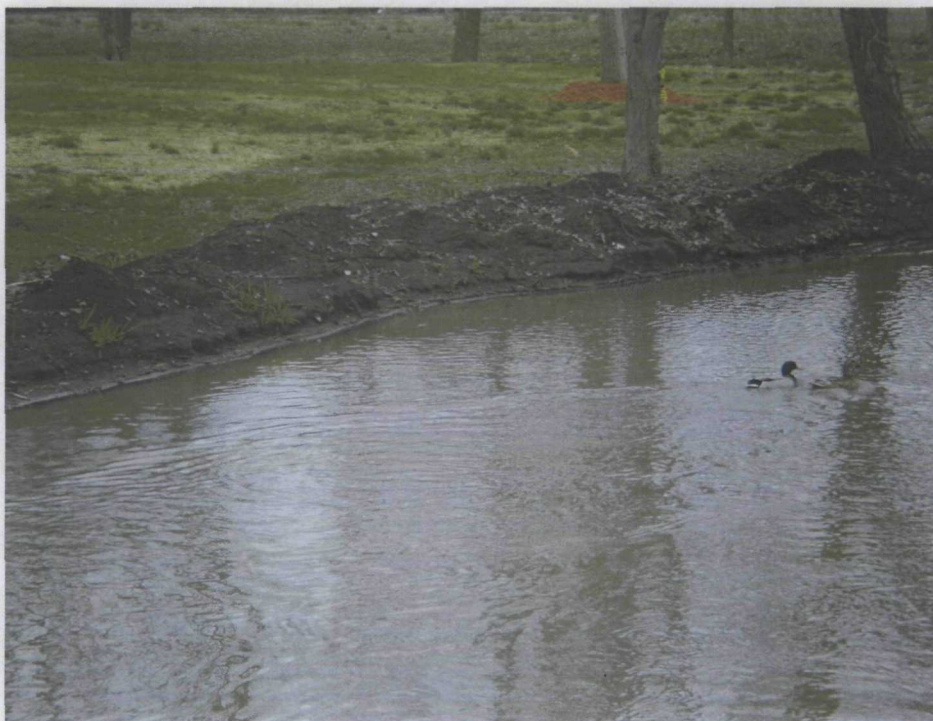
COMMENTS: Photo depicting that sediments from Long Lake has been dredged by local residents. Also the area is used by mallard ducks.

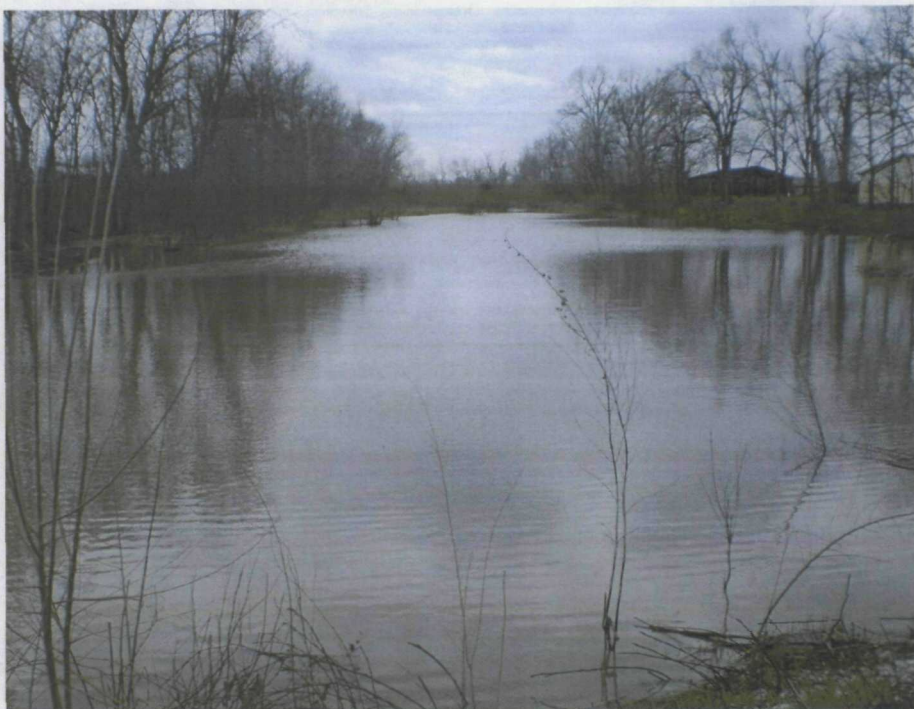
COMMENTS: Photo taken of Long Lake to the south.

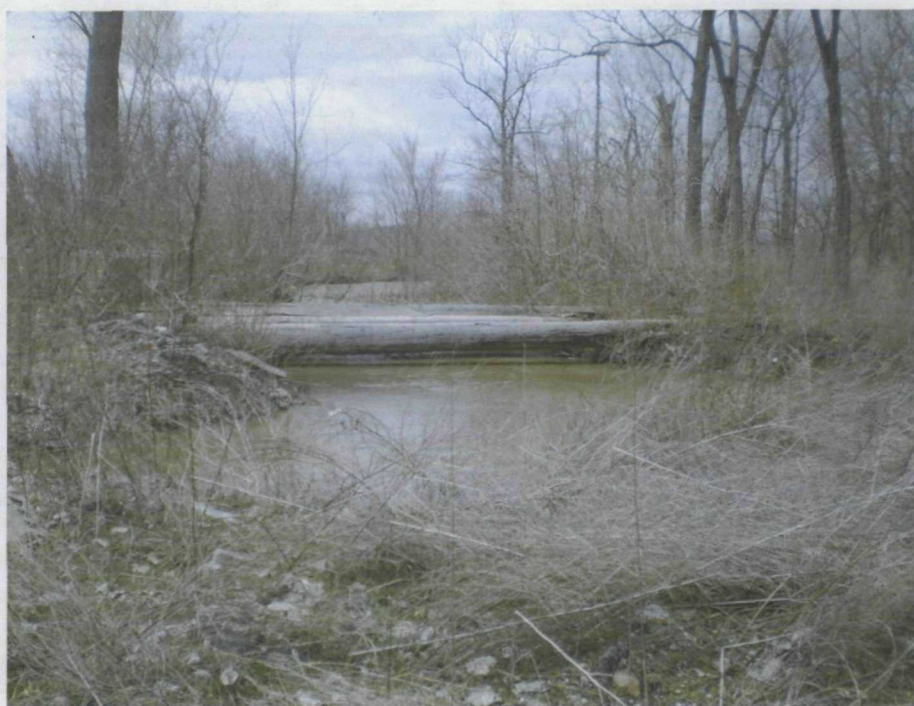
COMMENTS: Photo taken of the southern most section of Long Lake. Just after this point the Lake is directed to an unnamed canal. This canal then runs to the south. A more precise surface water pathway is discussed in the 2008 ESI.
